RESPONDING TO THE PROBLEM OF IRON IN GROUND WATER

INTRODUCTION

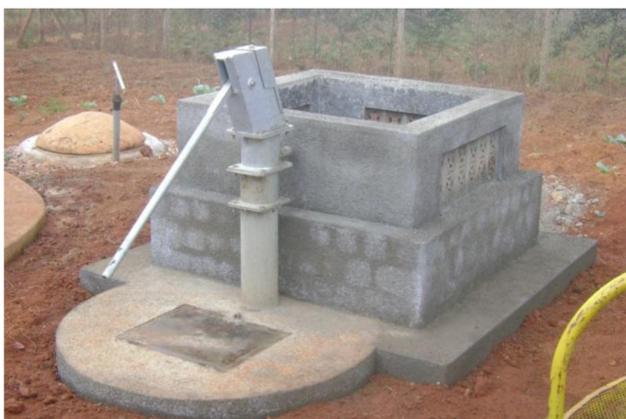
This is a simple chamber constructed to allow sufficient oxygen into water such that ferric iron precipitates are formed. These are then filtered out using a sand filter media.

The chamber is constructed at the outlet of a water source with high iron content such as a borehole and the spout is modified to distribute the water through a perforated pipe. Aeration is further enhanced by using aerator plates (perforated aluminium sheets). When the water comes into contact with oxygen the ferrous iron dissolved in the water will get oxidized by air that flows through vents on the sides of the chamber.

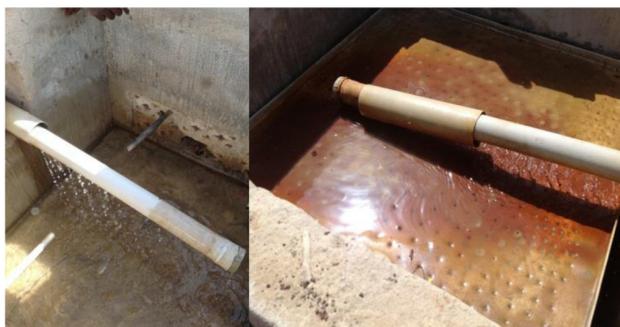
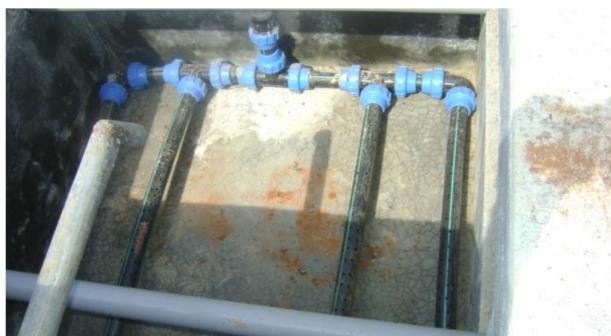
Silsoe design. Rainwater was then pumped into the tank and iron II sulphate at different doses was artificially introduced into the tank and the water pumped through the IRP to determine its efficacy. The study showed that up to 8 mg/l of water, the iron content was reduced to levels acceptable for drinking water by WHO. However for an initial iron content of 26 mg/l, the residual iron in the treated water was 5.93mg/l which is significantly higher than the WHO guideline.

The ATC constructed an IRP on its premises and built a 1,000l tank adjacent to it. This design was based on Eng. Ahmed Ssentumbwe's improvement of the
